The Jewel of Muscat

RECONSTRUCTING A NINTH-CENTURY SEWN-PLANK BOAT

Tom Vosmer

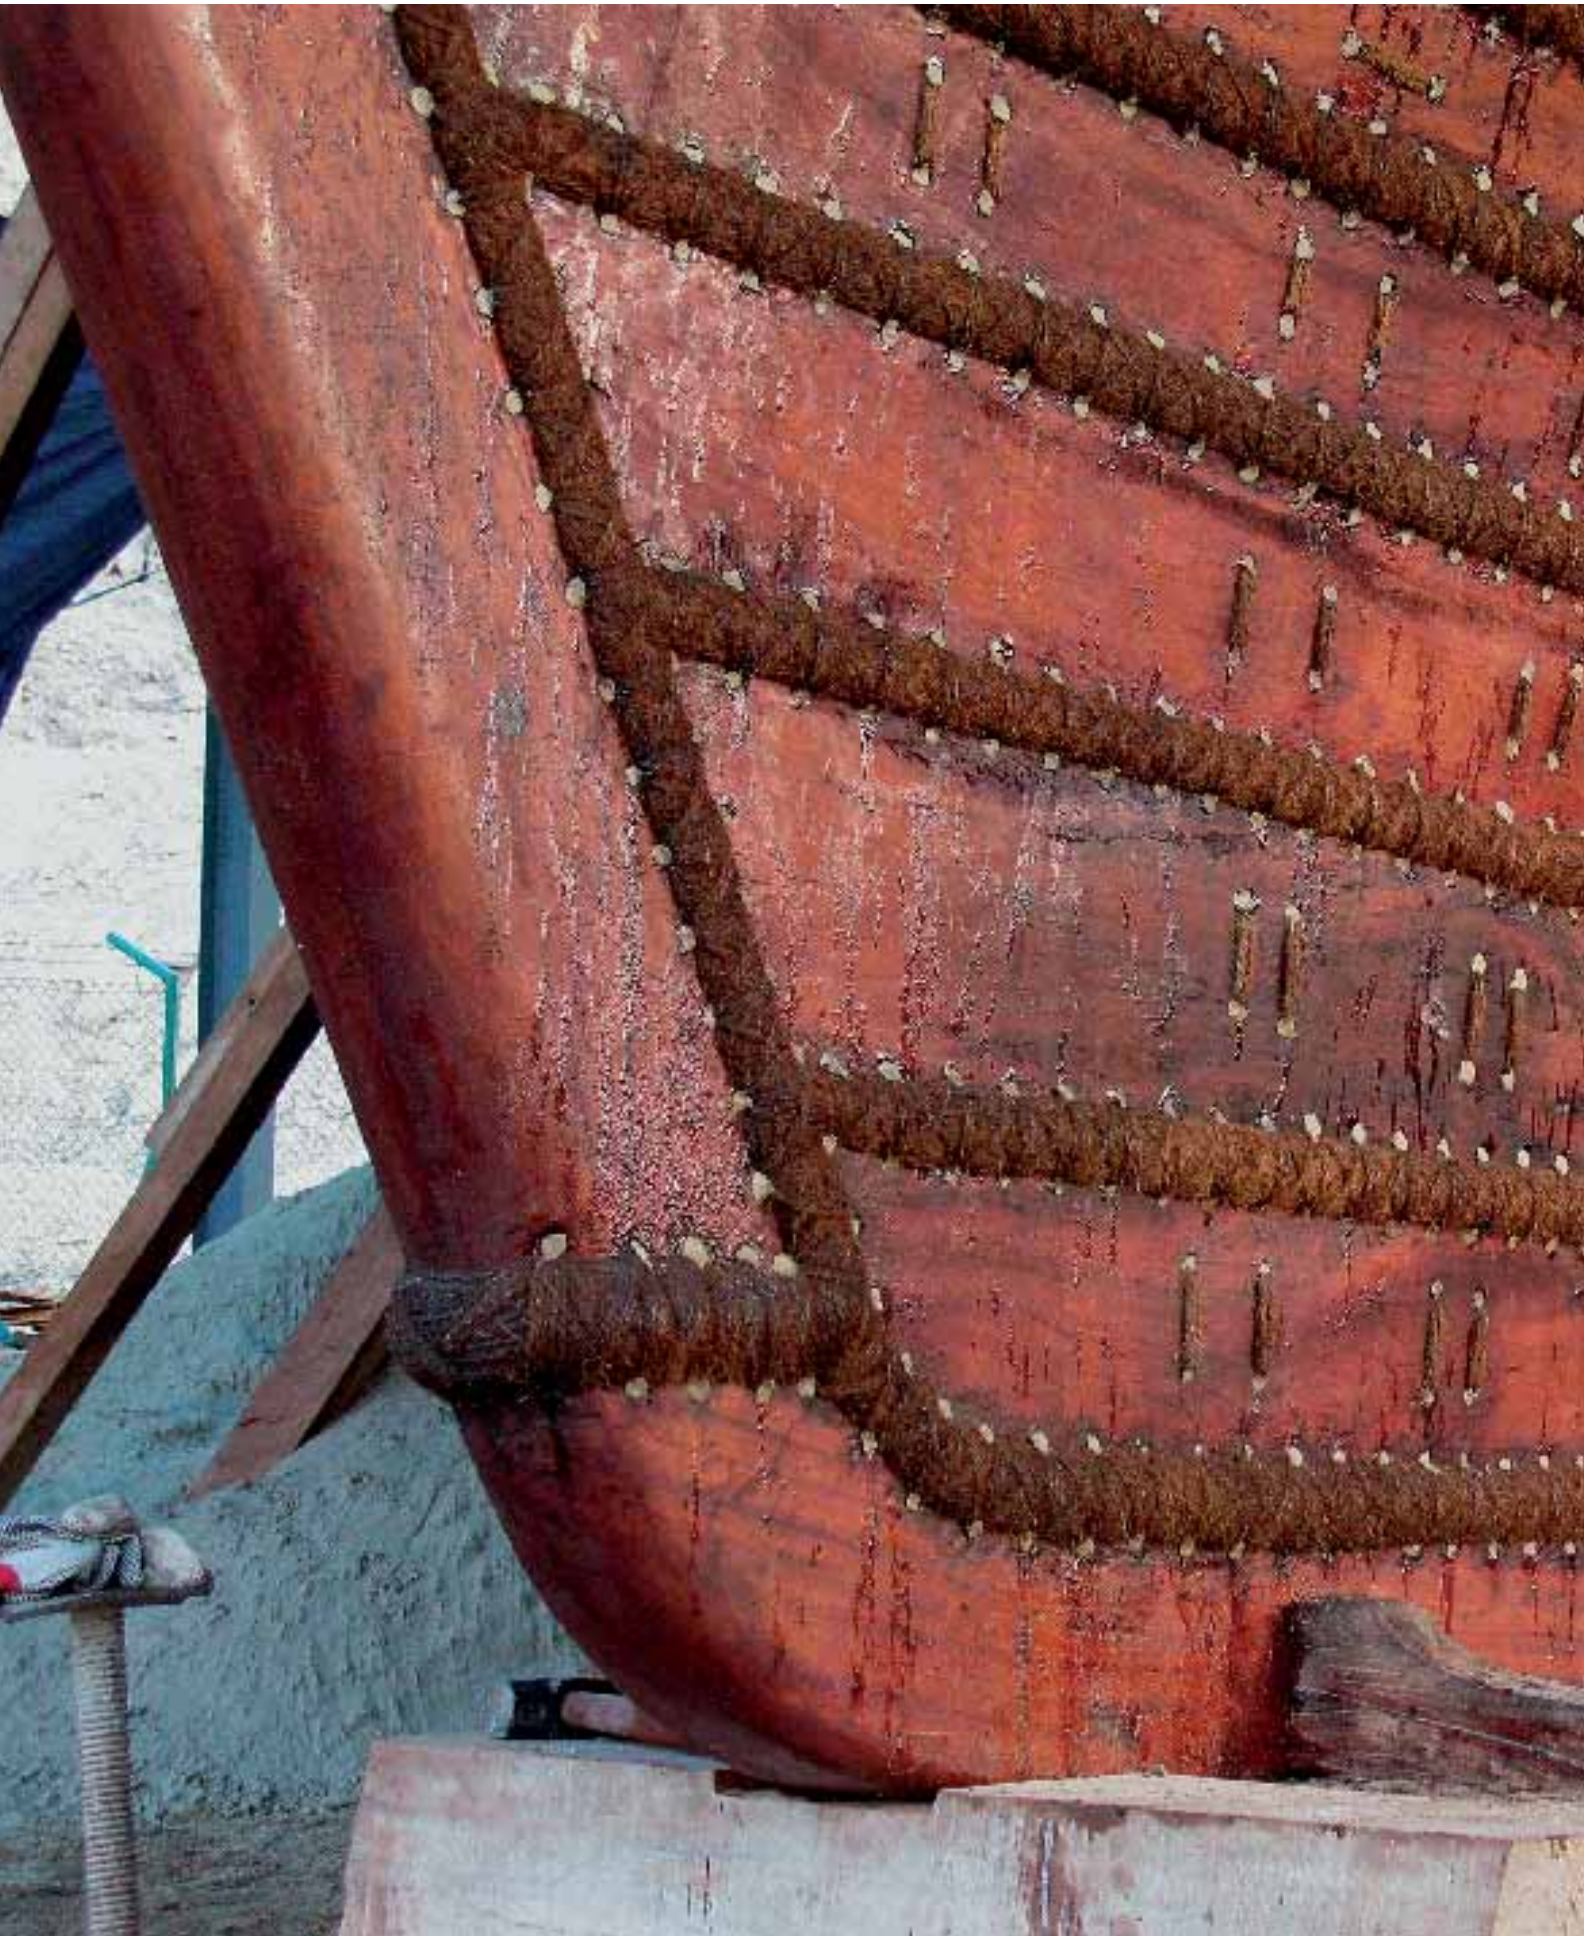
Fig. 88 View of the forefoot, showing the stitching holes plugged with putty.

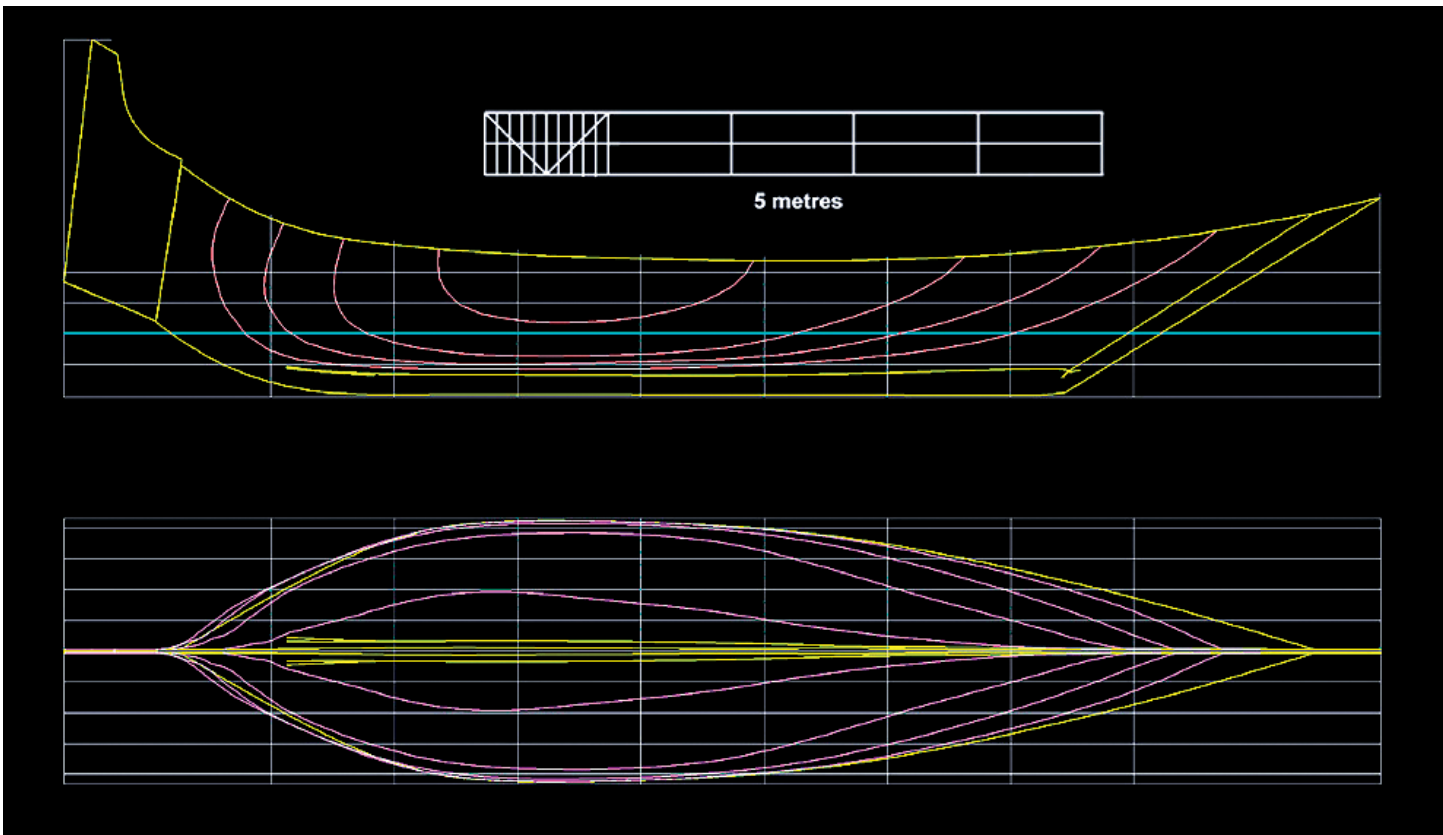
Fig. 89 Drawings of a typical *bati* hull form.

The remains of the bow showed it had been narrow and relatively straight, but the distribution of the cargo indicated fullness just aft of the ship's midpoint, similar to the form of the *batil*-type vessel in recent Omani nautical history. The volume of the cargo—the sheer number of ceramics and other artifacts—indicated the ship had been capacious, and this was confirmed by the extant planking. From the intact hull planking amidships it was clear that the ship had had a large girth and, therefore, a broad beam. From the angle of the stem, the half-girth amidship, the shape of a possible floor timber, the twist of the garboard (the first plank, adjacent to the keel), and the angle of the rebates for the planking in the through-beams, much could be determined about the shape of the forward portion of the hull.

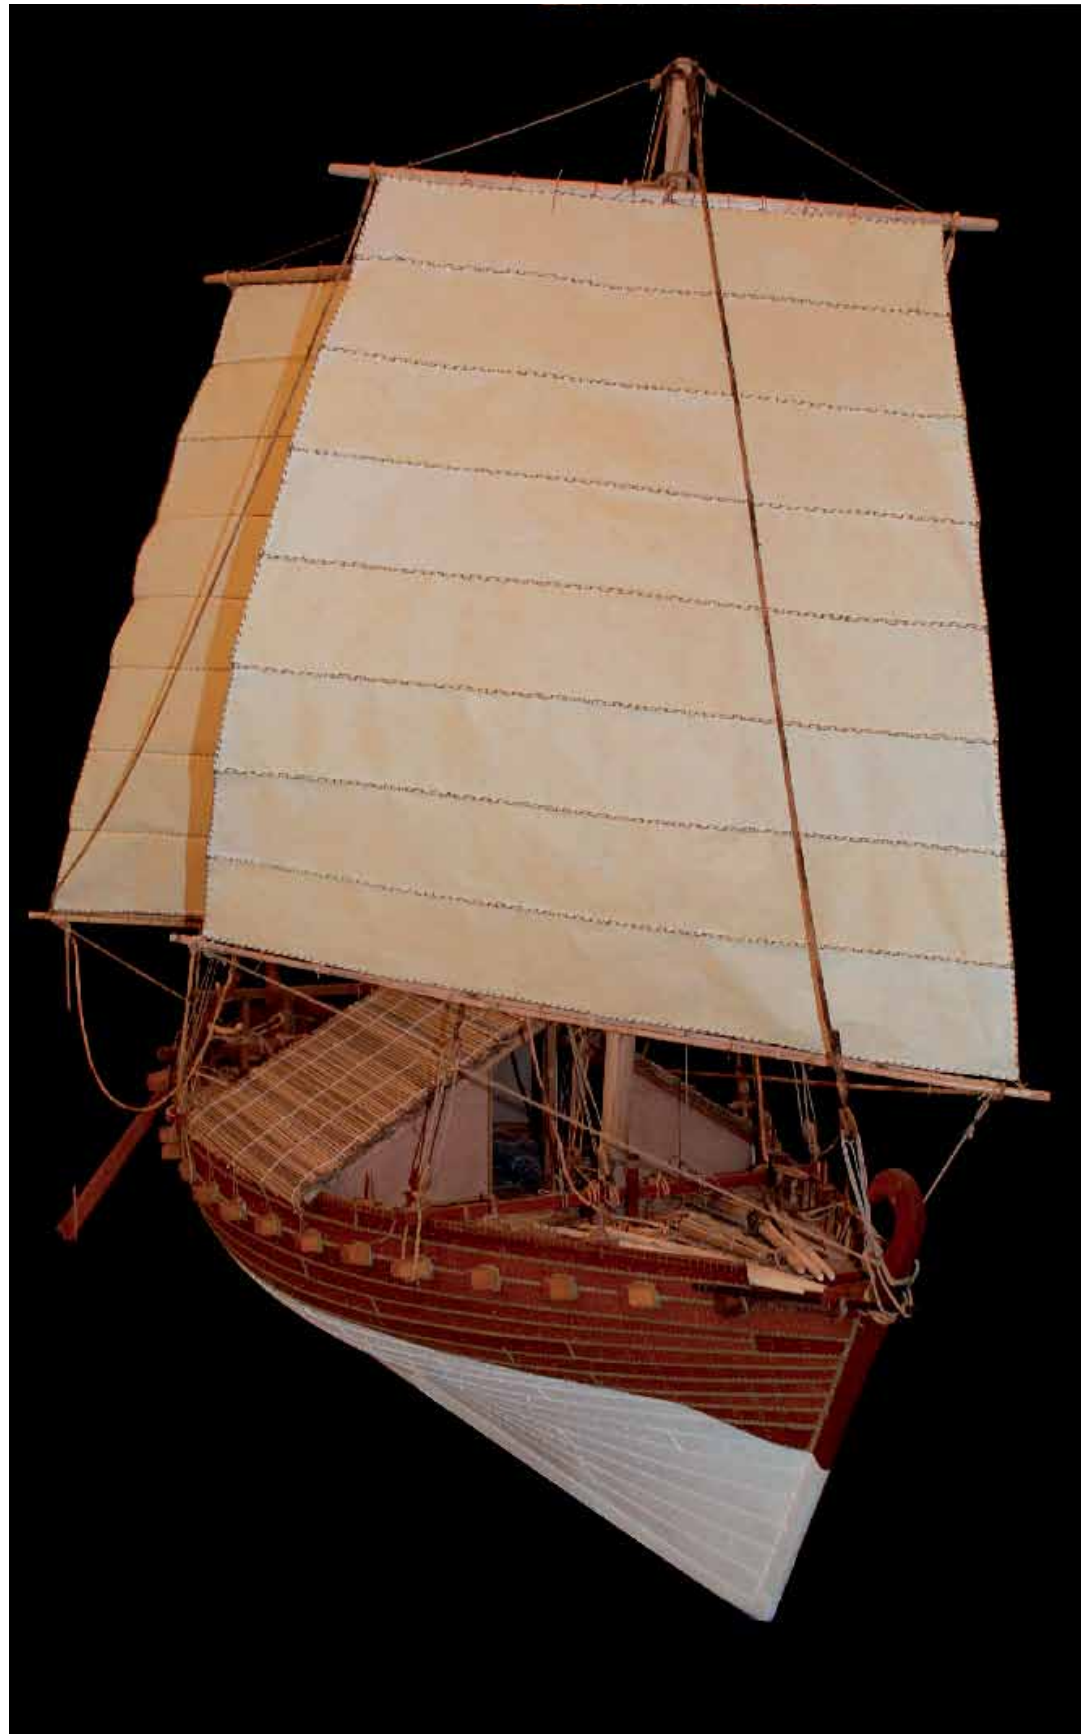
Fig. 90 Model of the Jewel of Muscat, built by Nick Burningham. Cat. 1.

Based on this design, Burningham built a model (figs. 90–91), intended as a learning device as well as a representation for display. The process of building the model revealed procedures and structural problems that could then be resolved on a small, relatively inexpensive scale. The model would also be a handy reference tool for the Indian and Omani shipwrights, who were

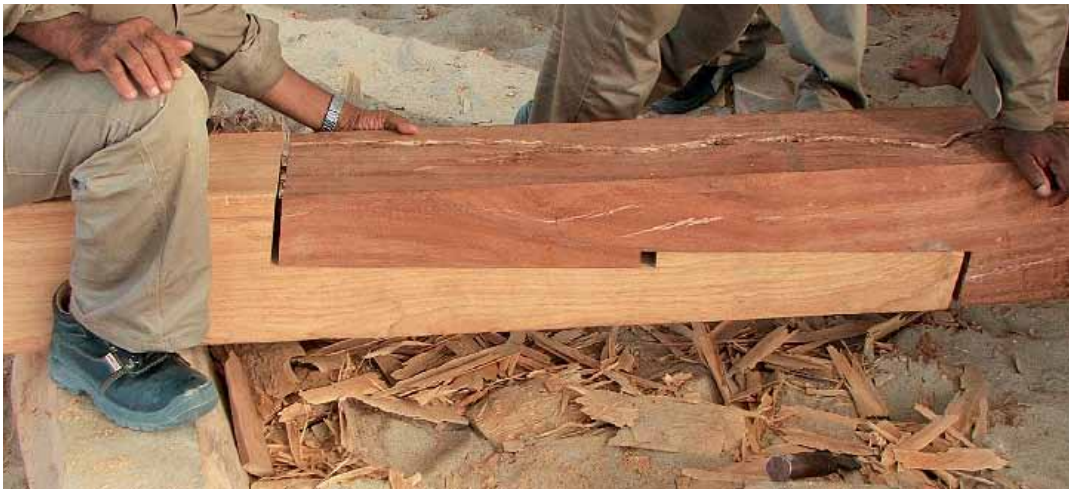
Fig. 92 To create the scarf joint, a tenon projecting from the stempost is fitted into a slot cut in the keel. The same is done with the sternpost. Then both posts are sewn to the keel.

The curving portion of the keel in the stern was securely fastened to the forward portion by a complex scarf (sloping) joint (fig. 92), and then the stem and sternposts were erected. The heel of the stempost had a tenon projecting from its underside. This was fitted into a slot cut in the top of the forward end of the keel. A similar arrangement was made for the sternpost. The stem and sternpost were then sewn to the keel.

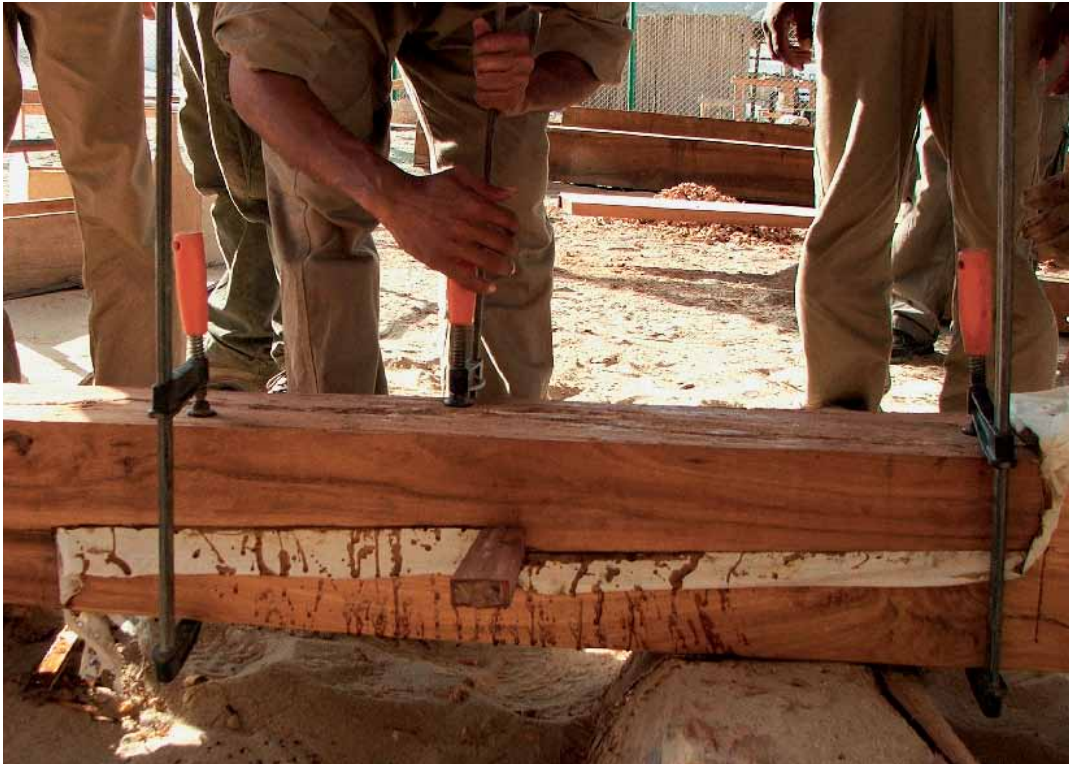
Fig. 93 Placing sea-soaked planks in "torture racks" was found to be a less-than-ideal way to curve them into shape.

to soak the planks in the sea to make them more pliable, then place them in “torture racks” to be forced into the desired shapes and allowed to dry (fig. 93). This method, however, was found not to be completely effective. Another method was fire-bending, where the plank, soaked in water or oil, was heated over a fire and simultaneously forced into the desired shape. Application of heat on one side of the plank tended to make that side concave. Heat also made twisting a plank easier. When the plank cooled, it essentially would stay in the forced shape.

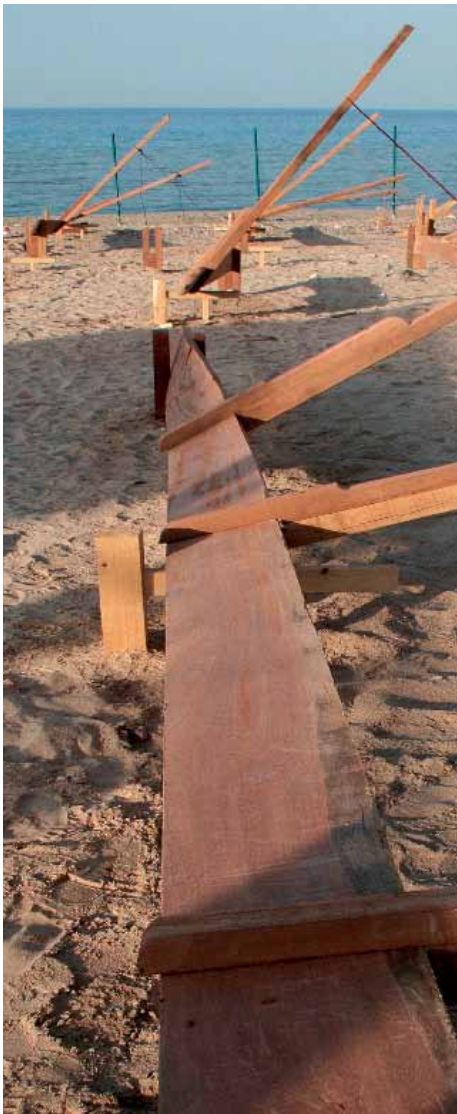
Fig. 94 Two men working on either side stitched the planks together.

Workers formed pairs to sew the boat, one inside the boat and one outside (fig. 94). Each had an identical tool kit—a marlin spike (a tapered wooden lever about 50 centimeters long), a heavy mallet or hammer, and small tapered wooden plugs to lock stitches temporarily in the holes as they progressed. A piece of wire was twisted around the end of the stitching cord so that it could be easily pushed through the holes. The sewing cordage, a doubled length of coconut rope 3 millimeters in diameter, was first passed through a hole, over the wadding on the plank to the person on the opposite side, who drew the cordage up tight, using the marlin spike as a tightening lever. To further tighten the stitch, the cordage was hammered over the wadding while the lever was tightened. The sewing proceeded in a zigzag pattern, and when the end of a section was reached, the sewing direction was reversed, returning to the beginning. The end result was a series of X-shaped stitches alternating with vertical stitches (fig. 95).
